NRL/MR/6120--97-7957

# Control of Lead in Drinking Water

ROBERT F. BRADY, JR.  
JAMES D. ADKINS

July 11, 1997

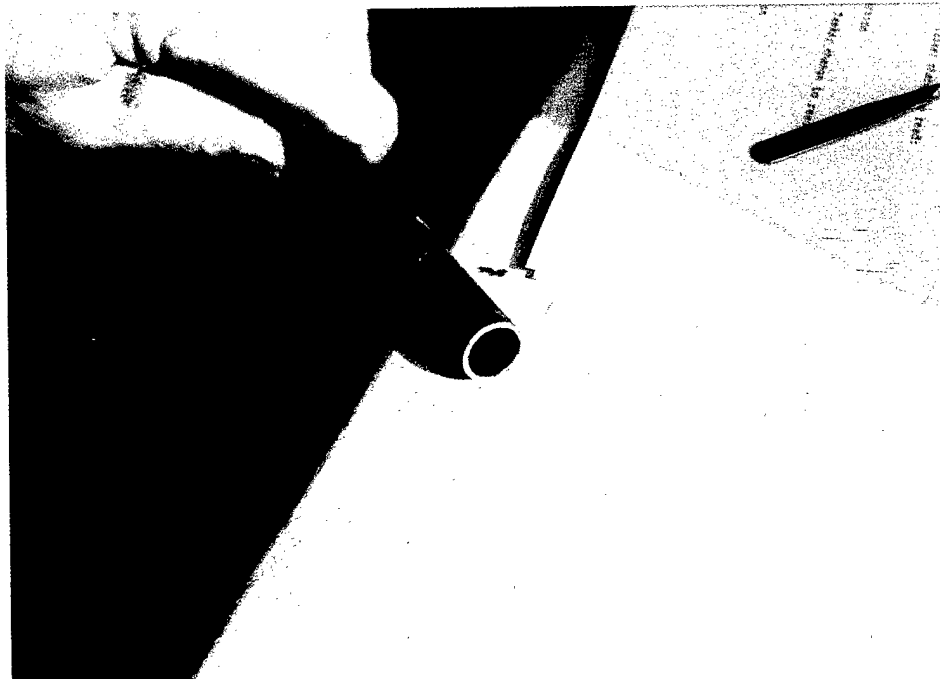
Figure  
4

Paint in the cold water riser to room 214 was rippled, indicating that it sagged before drying; thickness is reasonable but the paint has entrained grit which makes it rough (Figure 4). Where this line became horizontal and entered the main, the coating was thicker on the bottom of the main (Figure 5).

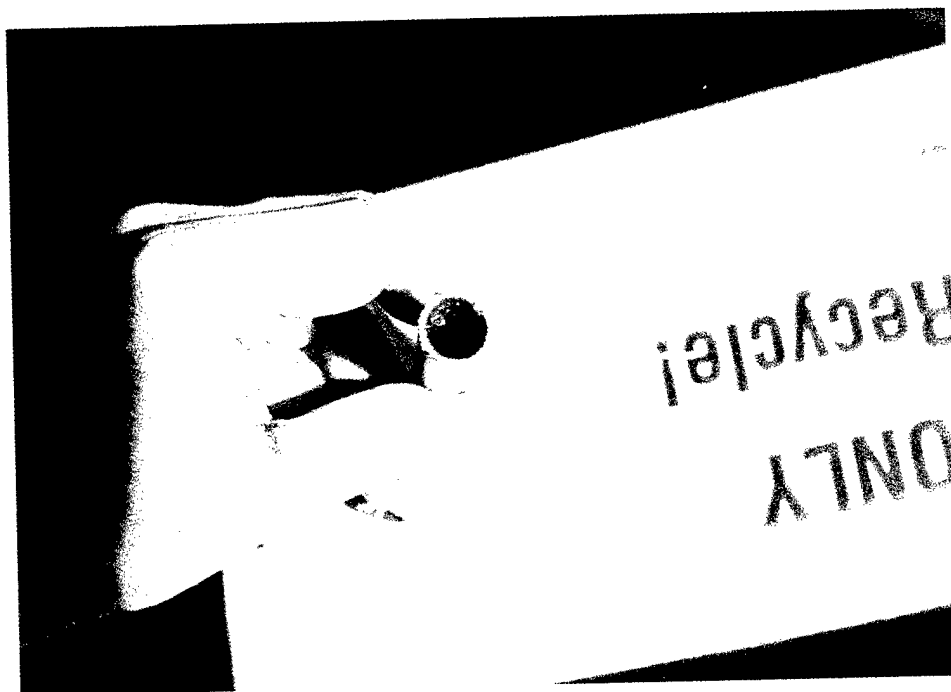
Figure  
6

The cold water line to room 211 showed proper thickness and good adhesion, but contained much entrained grit (Figure 6). Some of the pipes, such as the cold water feed in room 210, contained excessively thick coating or no coating at all. In the cold water line to room 206, just behind the tap the coating is excessively thick and porous (Figure 7),

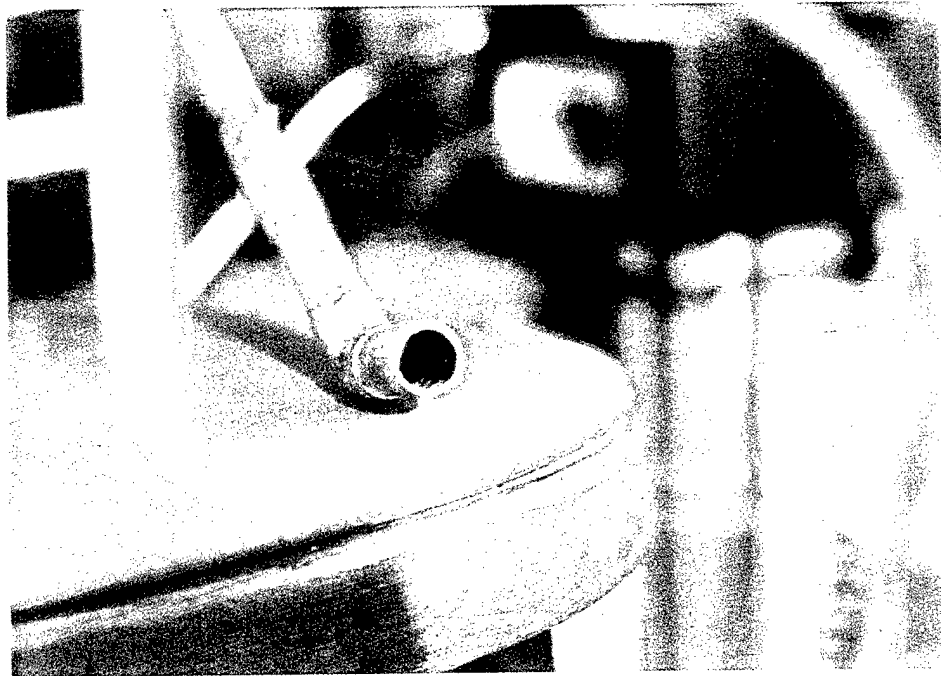
Figure  
8

but 24 inches toward the main there is no coating at all (Figure 8). The cold water line (Figure 9) to the ladies room near the first-floor lobby and to room 207 was at the upper limit of thickness on the bottom and very rippled.

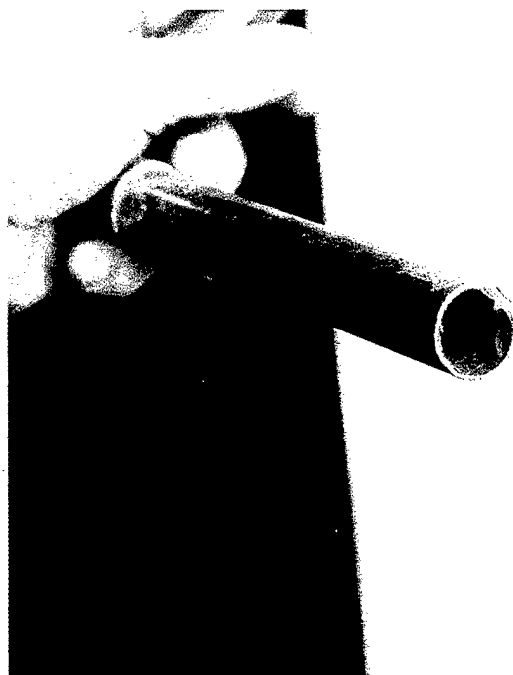
Figure  
10

The hot water line leading to laundry on the first floor between room 107 and the booking office showed good adhesion, but the paint is excessively thick and severely rippled (Figure 10). The lining in the hot water pipe to room 106 (Figure 11) was at the maximum permissible thickness and showed ripples, good adhesion, and some evidence of grit in the paint.

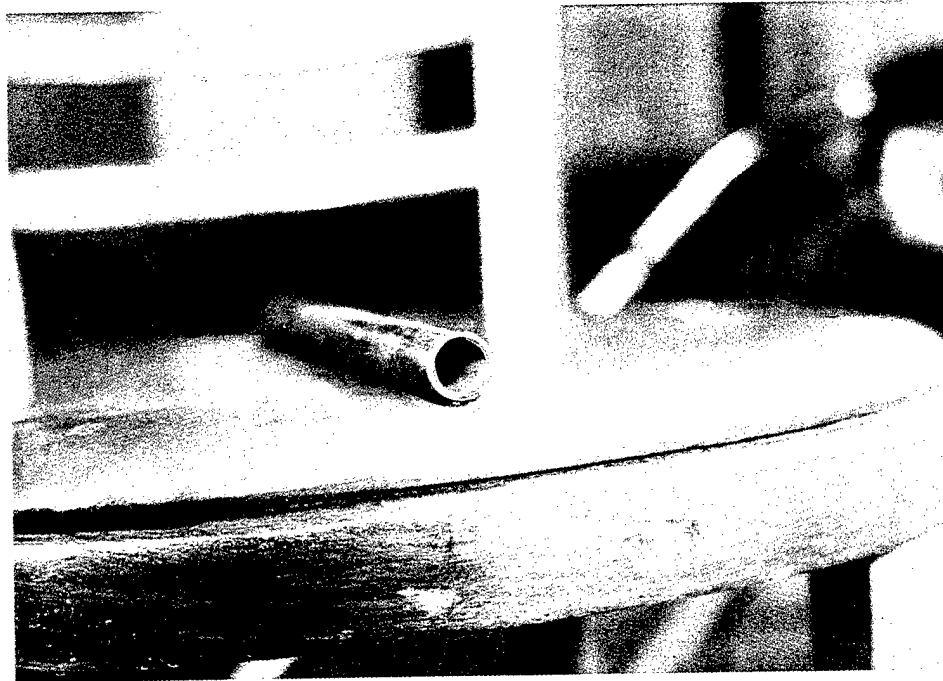
Figure  
12

The lining in the cold water feed to room 105 (Figure 12) was excellent, showing proper thickness, good adhesion, and no contamination. Lining in the hot water line into room 101 was hard and smooth, adhered well, but was slightly thick on the bottom of the pipe nearest the tap (Figure 13).

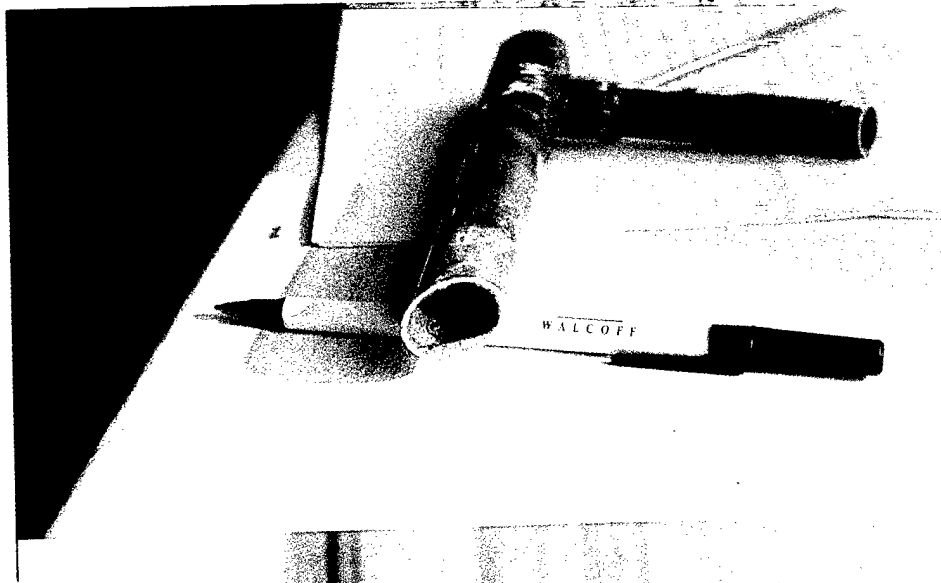
Figure  
14

Workmanship in the cold water main is good at the north end but very poor at the south end. At the north end, the lining is generally smooth and glossy, with light rippling. Adhesion of the paint seems satisfactory. The paint is thicker on the bottom of the main at the north end of the building (Figure 14), but not so thick as to obstruct flow.

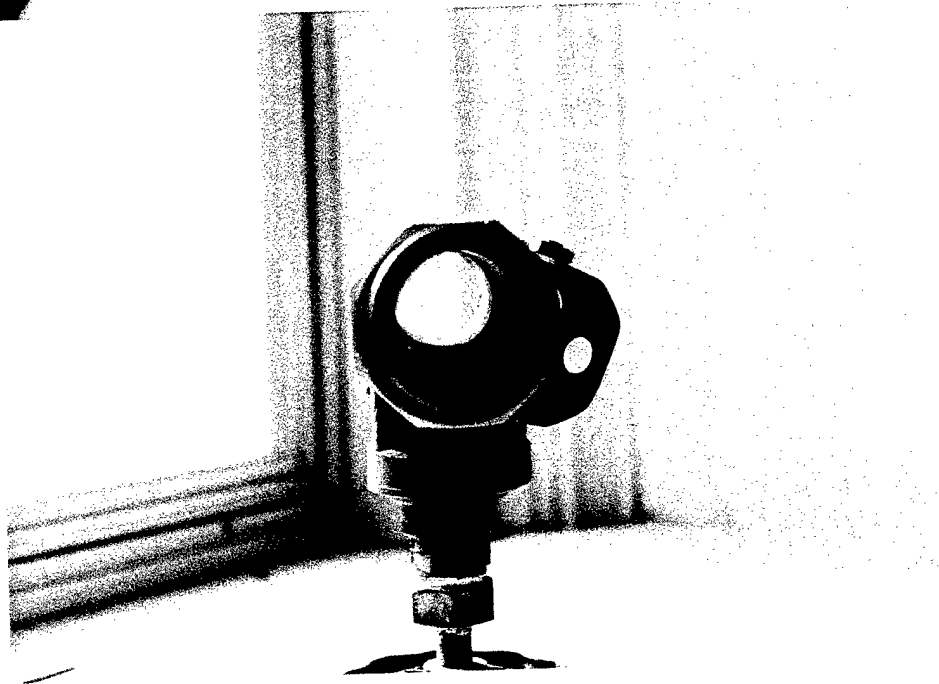
Figure 15 shows a valve and adjoining piping from the cold water main at the north end. The valve is operable but must pierce and crack paint in order to close. The coating is generally smooth, with light rippling but no blisters. Adhesion of paint seems satisfactory. Paint has a matte finish instead of the normal gloss.

All valves were painted, and most were inoperable (see Figures 15, 17 and 20 above). The contract explicitly required valves to be removed from the lines before painting.

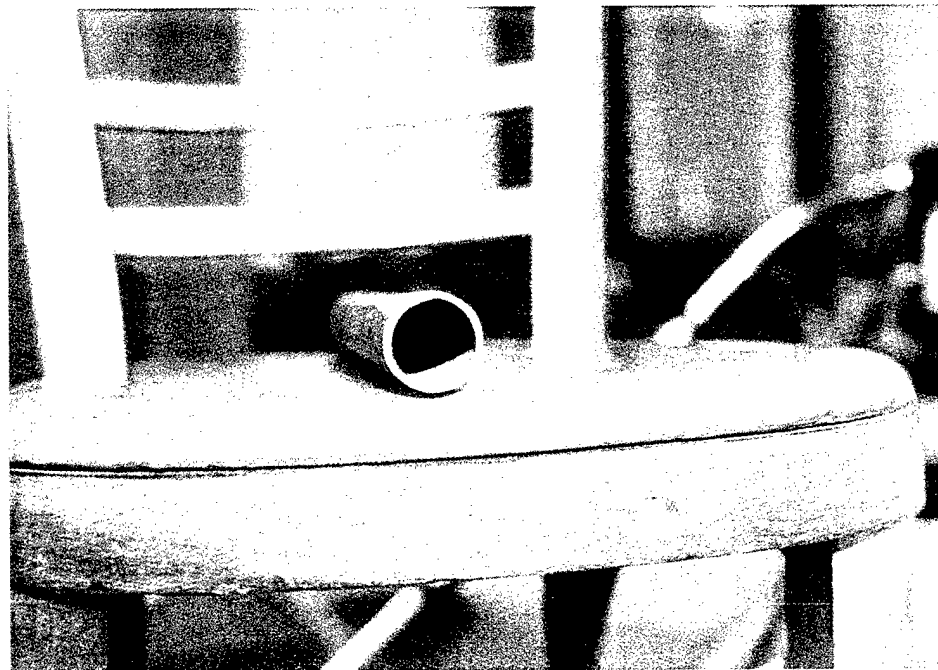
At the far south end of the building, the lining is excessively thick at one point, but stops abruptly leaving uncoated pipe. In a section of 1" cold water main from far south end of building, the paint is excessively thick at one end (Figure 18) but there is no paint at all at the other end (Figure 19). The roughness of the pipe surface at the uncoated end is very light on the bottom and sides, but there is no roughness at all on the top 60° of the pipe.

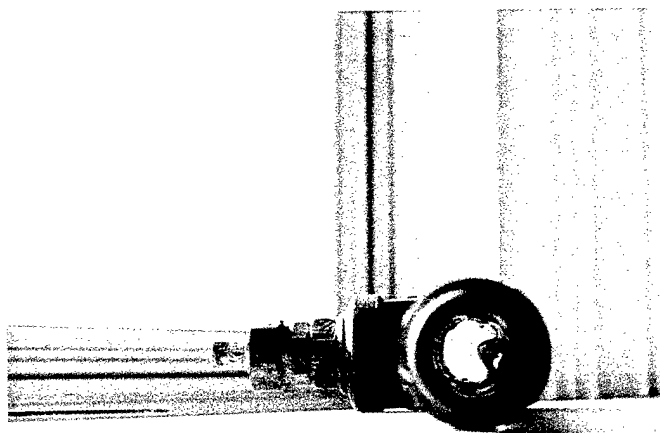
Figure 20 shows a section including a valve from the hot water main at the north end of the building. The thickness of paint in the pipe is acceptable, but the valve is painted open. A single blister about 8" long has formed at the top of the pipe. The interior metal surface of pipe is very smooth; there is no surface roughness at all.

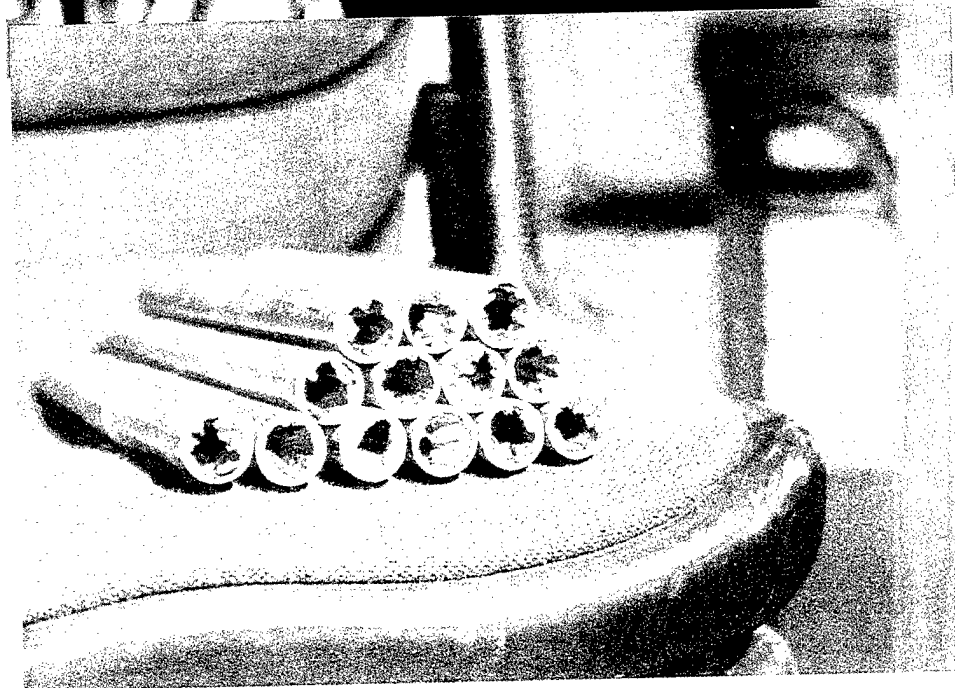
Figure  
25

A 13-foot section of 3/4" hot water recirculating line from the far south end of the building was nearly obstructed by excessively thick paint. A pipe cutter was used to cut this pipe into 13 1-foot segments, and these are shown in Figure 25. The lining is not solid paint but is porous.

5. A critical error in this work was that dust from blasting was left in the hot water recirculating line at the south end of the building.
  - a) When paint was added, dust and paint combined to form a viscous paste which entrained air and formed an excessively-thick, poorly-adhering, porous crust. This was most severe in the hot water recirculating line at the south end of the building.
